Ewing Mountain Vegetation Project Environmental Assessment

Draft Geology Report

Tom Collins

April 12, 2021

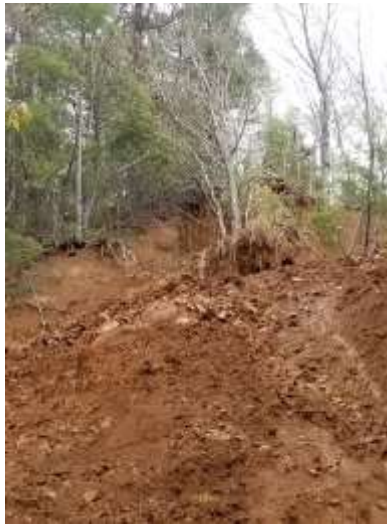
Figure 3. Landslide in highwall of Little Wythe mine south of Fry Hill (May 6, 2020).

The abandoned mine workings have resulted in slope instability which continues into the present. The Little Wythe mine is just south of Fry Hill. The highwall from the Little Wythe mining in the early 20th century is still unstable and producing new slope failures (Figure 3). The highwall has at least four recent landslides (Witt, A.C., 2020).

Past human activities (mining; timber harvesting; roads, etc.) have altered geologic conditions affecting slope stability in the project area, and as a result, increased the potential for slope instability and landslides. For example, the highwall from the Little Wythe mining in the early 20th century is still unstable and producing new slope failures (landslides) (Figure 3). The highwall has at least four recent landslides (Witt, A.C., 2020).

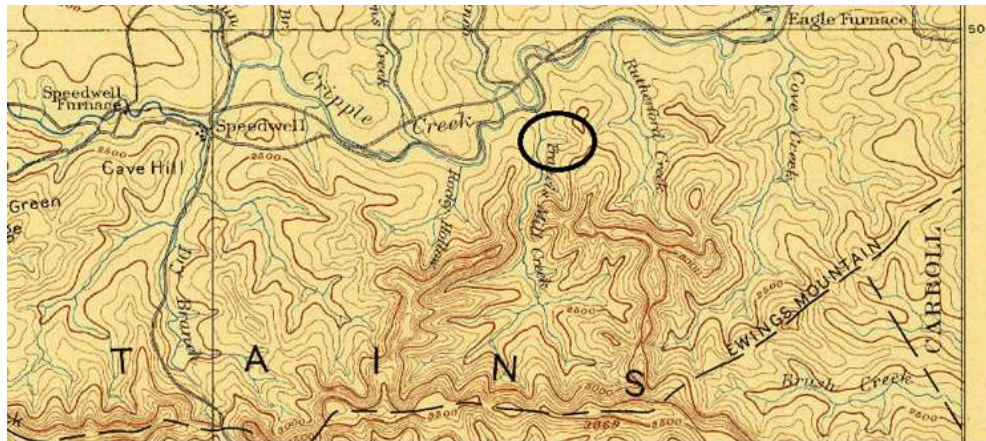
Figure 4. Stream valley tributary to Francis Mill Creek (circled area) on USGS 1889 topographical map (scale 1:125,000)

A stream valley tributary to Francis Mill Creek is shown on USGS 1889 topographical map (Figure 4). By 1930 the tributary valley was filled with sediment behind a detention dam constructed for ore washing operations. The tributary stream is buried under the sediment-filled reservoir and is not shown on the USGS 1930 topographical map (Figure 5).

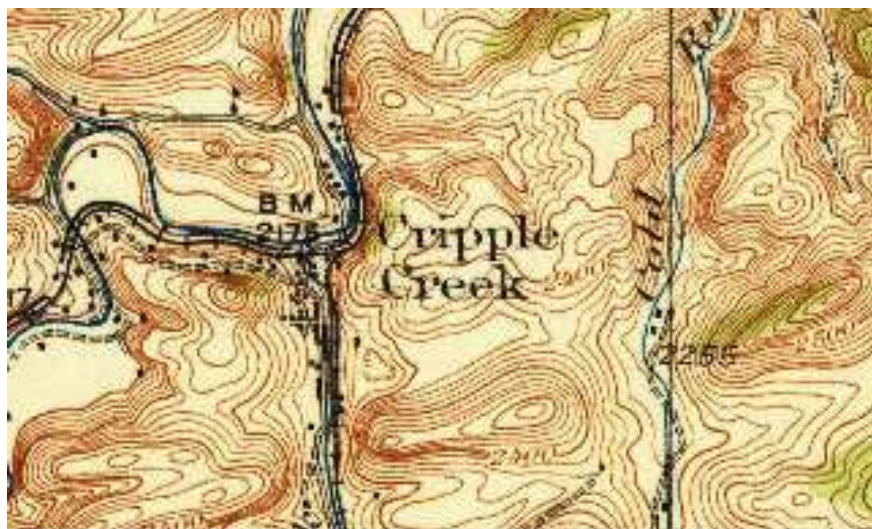
Figure 5. By 1930 the tributary valley was filled with sediment behind a detention dam constructed for ore washing operations. The tributary stream was buried and not shown on the USGS 1930 topographical map (scale 1:62,500)

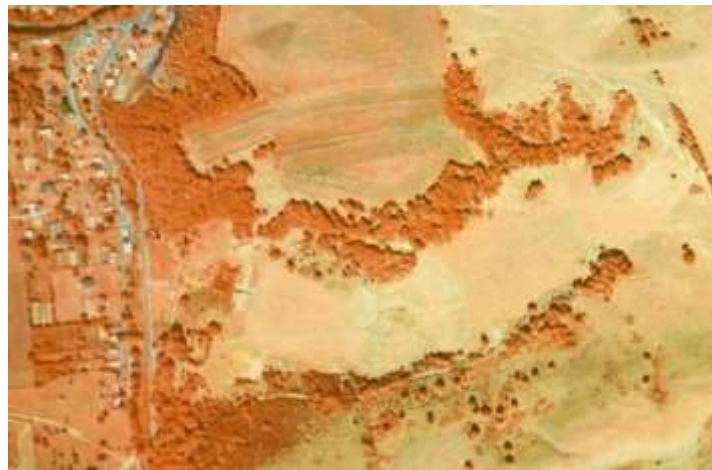
Figure 9. Sediment-filled reservoir used as pasture. 2,000' long pasture drains downslope to the detention dam. (September 1981 USDA aerial photo)

The sediment-filled reservoir has been used as grazing pasture for decades. The pasture land is a few hundred feet wide and extends about 2,000 feet upslope from the dam (Figure 9). With only a grass cover, the pasture is subject to surface flow from storm water. During intense rainstorms the storm water flows toward the dam crest.

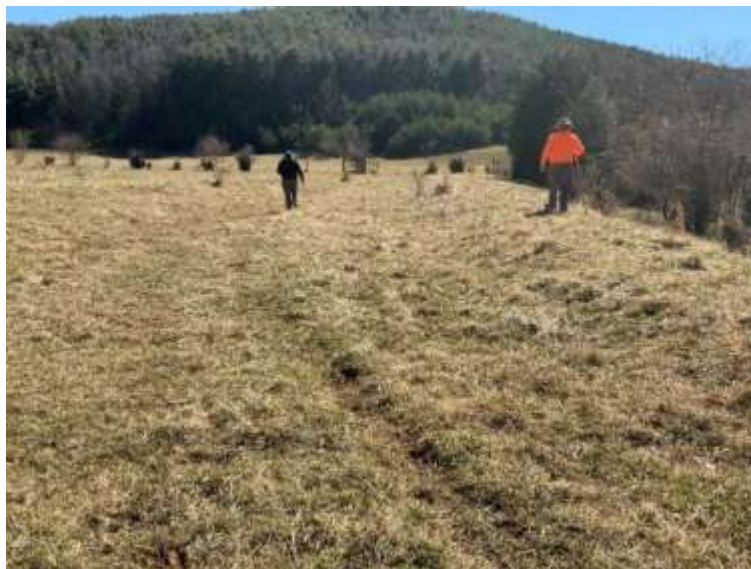
Figure 11. Berm along crest of detention dam (view to south).
Person on right stands on top of berm. Person on left stands along edge of pasture (sediment-filled reservoir) that extends about 2,000 feet upslope from the dam

The berm on the crest of the dam acts as a mini dam (Figure 11). The berm is intended to keep the flood waters from overtopping the dam. If the flood waters rise too high against the berm, the spillway is intended to divert the flood waters to another drainage (Figure 12). But the berm of earthen materials is only a few feet high, and is vulnerable to erosion by flood waters, and to breaching or overtopping.

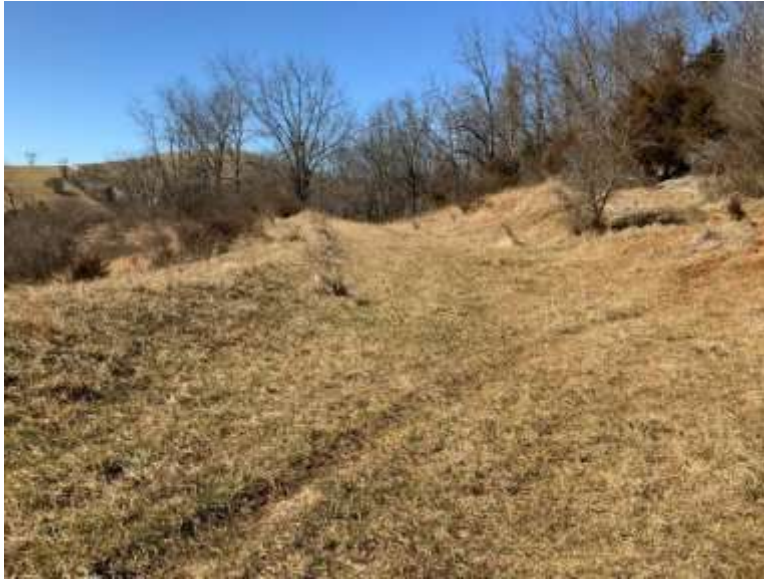
Figure 12. Berm along crest of detention dam (left foreground) transitions into berm along spillway (left middle ground) (view to north)

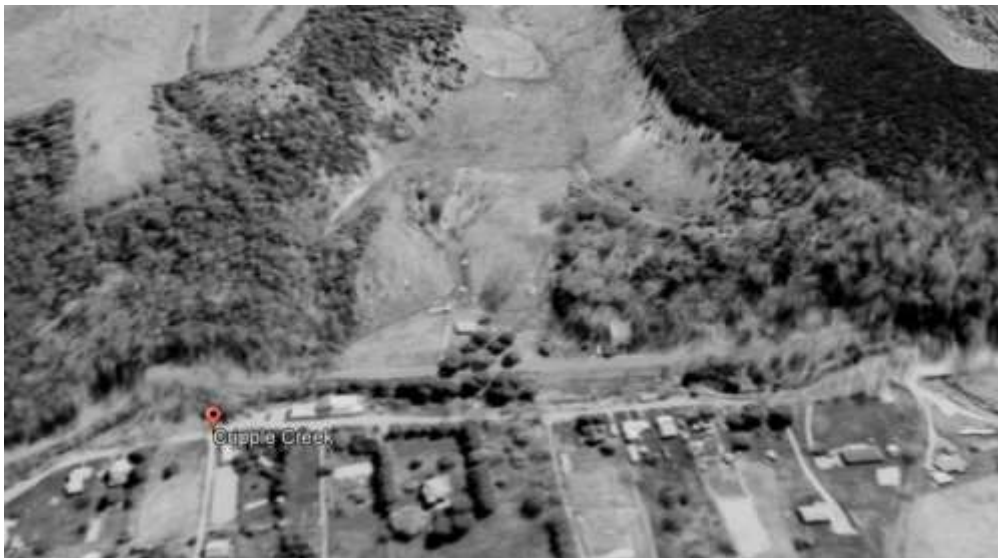
Figure 13. Abandoned detention dam with sediment-filled reservoir next to Cripple Creek community, Wythe County, VA. Gully erosion visible on face of dam. (2001 aerial photo; view to the east)

The detention dam is adjacent to the east side of the Cripple Creek community (Figure 13). The abandoned dam has not been monitored or maintained for decades. The dam and sediment-filled reservoir have hazards and risks to public safety, infrastructure, and resources. A failure of the dam embankment could result in flooding and a debris flow/mudflow that would put lives, infrastructure, and resources at risk. The past and present use of the sediment-filled reservoir and adjoining slopes as a grazing pasture increases potential storm flow downslope to the dam.

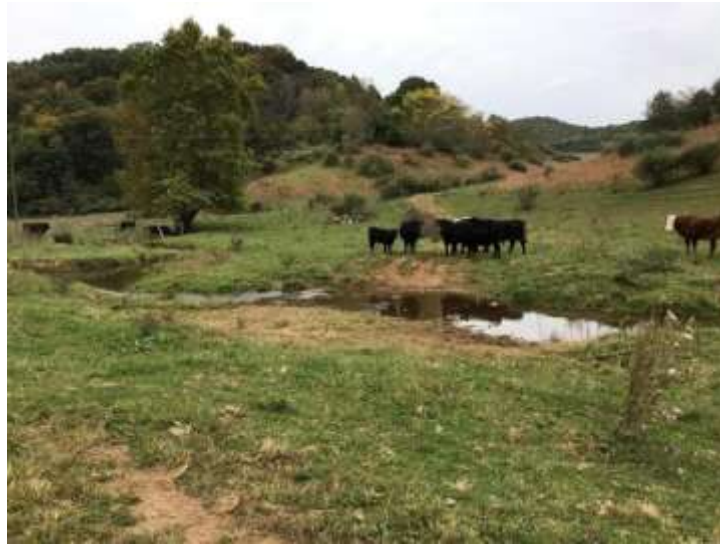
Figure 15. Grazing in Cripple Creek grazing allotment located in carbonate geology-based ecosystem (karst)

Secondly, the grazing livestock churn up the ground surface and make the area more susceptible to erosion and Increased sedimentation. Third, the non-system roads used in the pastures are another source of erosion and sediment. Fourth, the livestock tread into the surface drainages and streams, and affect aquatic resources (Figure 15). Fifth, the livestock deposit thousands of tons of solid and liquid waste in

the pastures. As a result, pollutants percolate into the ground and wash into the surface waters. The deposition of livestock wastes every year into the pastures in this karst ecosystem is an ongoing hazard for contamination of surface waters and groundwater.

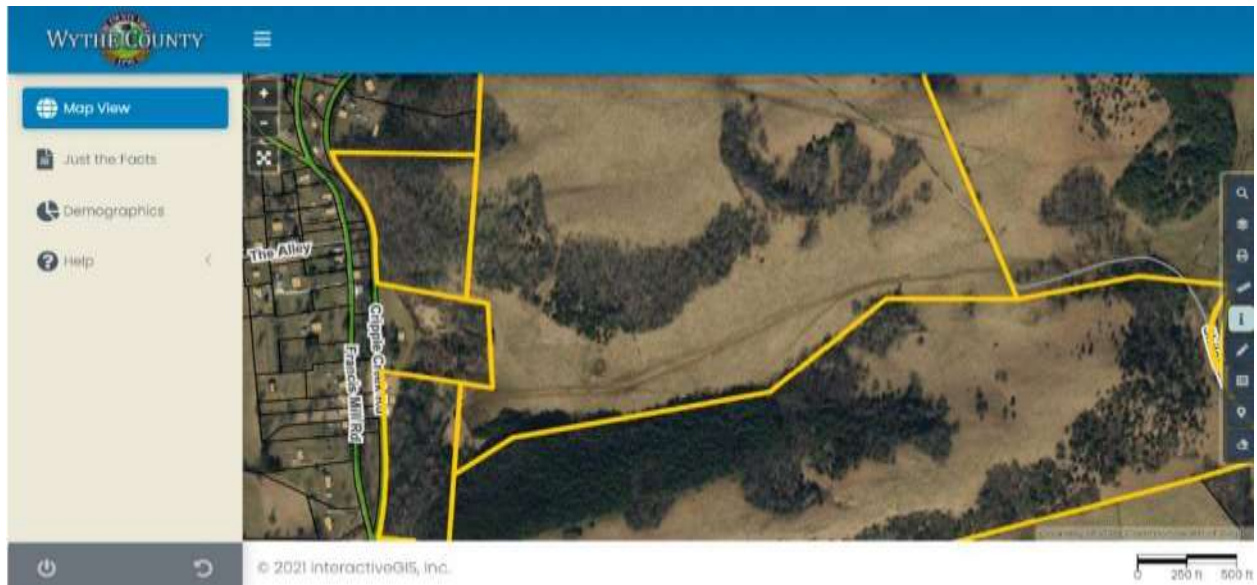
Figure 24. Wythe County GIS map showing Cripple Creek community near detention dam and sediment-filled reservoir used as pasture

The risks associated with the dam hazards are risks to public safety, infrastructure, and resources. The dam is next to the Cripple Creek community (Figure 24). A failure of the dam embankment could result

in flooding and a debris flow/mudflow that would put lives and infrastructure at risk. A failure of the dam embankment and a large mass of the sediment reservoir could result in flooding and a much larger debris flow/mudflow. One result from a geotechnical assessment of the hazard could be a map of potential inundation zones which would help to assess areal extent of risks. It would also provide a basis to estimate potential sediment discharge into Francis Mill Creek and Cripple Creek due to a dam breach and debris flow/mudflow.
